# Prediction of landslide occurrence in urban areas located on volcanic ash soils in Pereira, Colombia

D. A. Rios · M. Hermelin

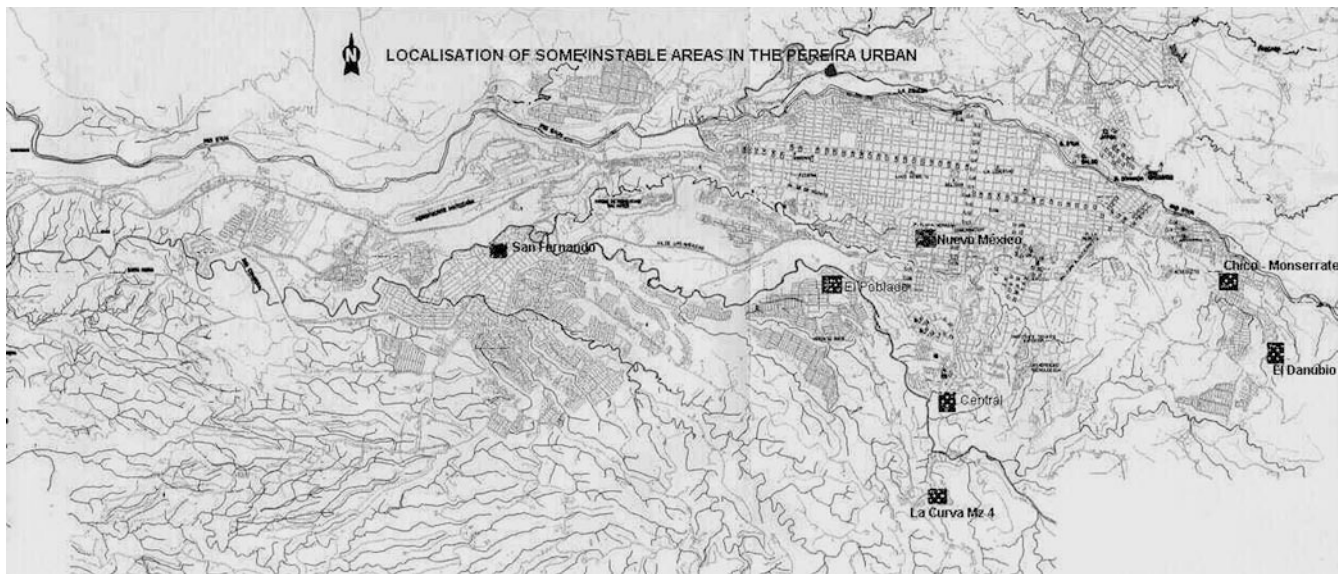
**Fig. 2**

Localization of unstable areas in the Pereira urban area

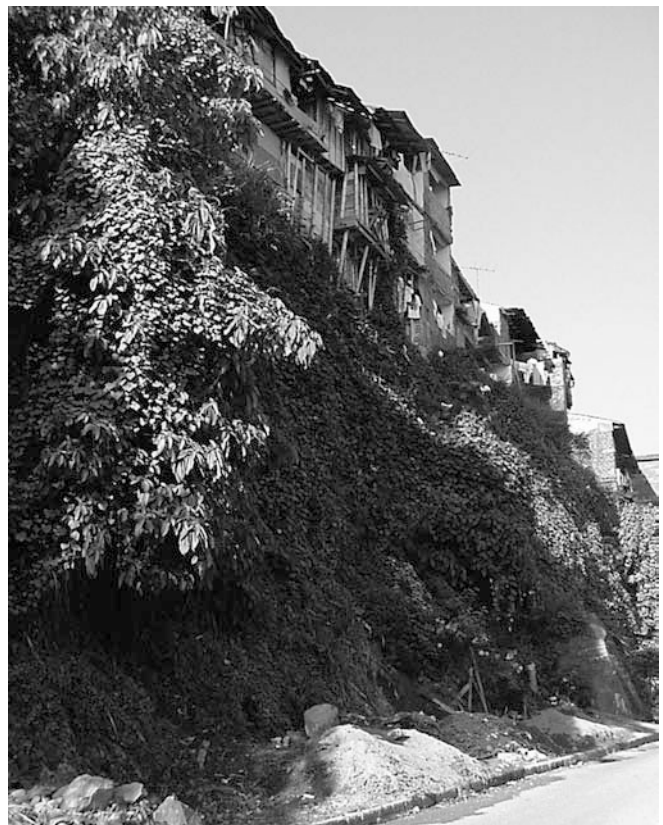
**Fig. 3**

Scene of earth-filled area affected by a slide, Barrio Caracol, Pereira

Two hundred low income families live in Caracol La Curva (Fig. 3). The methods used were topographic surveys and visual monitoring, which allowed small displacements in

the underlying earth-fills to be detected. The slope where this settlement is built has a height of 10 m and a length of 150 m, with gradients of almost 100% (45°) in the upper part and about 20% (10°) in the lowest third.

The deposits consist of clay with alluvial clasts and, importantly, very heterogeneous, non-compacted, man-made fills. Both infiltrated rainfall and waste waters from the community contribute to the progressive development of slope instability.

As a result of the monitoring process, several houses were evacuated. Two were destroyed by the 24 February slide, 6 weeks after evacuation.

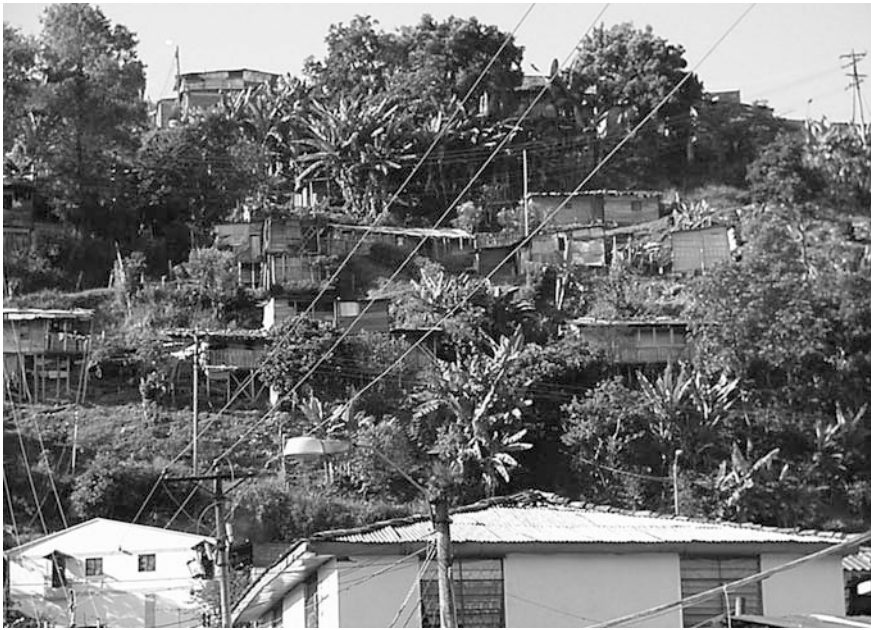
**Fig. 4**  
Slope in Chico District, Monserrate (Pereira)

This slope was monitored by visual observations (Fig. 4). Its height is 50 m, its length is 100 m and it supports 25 illegal buildings. The natural soils are covered by man-made earth-fills with thicknesses of 2–5 m and contain a significant proportion of litter. The slope reaches 100% (45°) in several places and its natural moisture content is very high, particularly in the middle of the slope. The houses have been affected by small mass movements and several showed cracks, sliding and water infiltration in floors and walls.

After evacuations were carried out in March and April, three slides occurred on 22 and 23 June 1999, mainly affecting the evacuated areas.
