Failure analysis of a car suspension system ball joint

E.A. Ossa^{a,*}, C.C. Palacio^{b,1}, M.A. Paniagua^{a,2}^a Materials Engineering Research Group, Eafit University, Cra. 49 No. 7 sur 50, Medellin, Colombia^b Applied Electromagnetism Research Group, Eafit University, Cra. 49 No. 7 sur 50, Medellin, Colombia

This study describes the analysis and investigation of the causes of the sudden failure of a MacPherson strut suspension system ball joint. The axis of the ball joint element showed a complete fracture which occurred midway between the top and bottom section changes of the element, as shown in Fig. 1. The failed ball joint element is shown in Fig. 1, along with a ball joint element not previously used, in order to show the height at which the fracture occurred in the element.

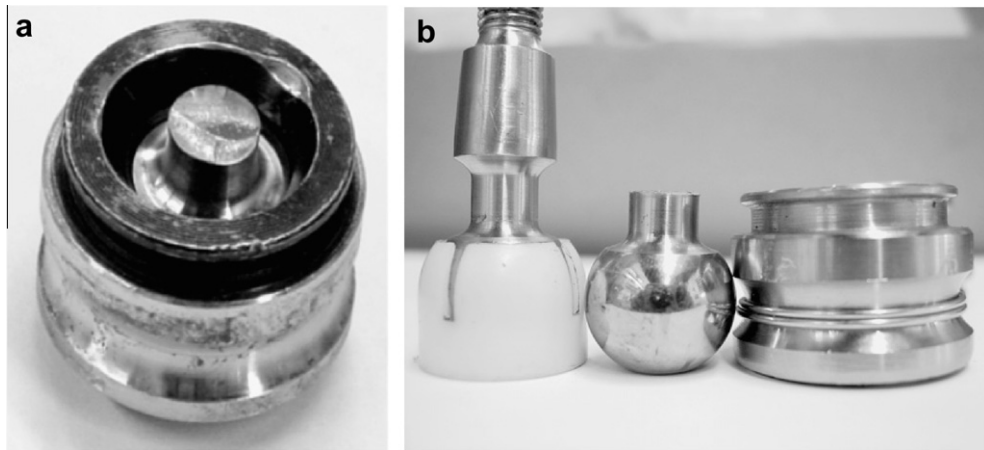
Fig. 1. Ball joint element. (a) Failed ball joint in the cage. (b) Failed and new ball joints out of the cage.

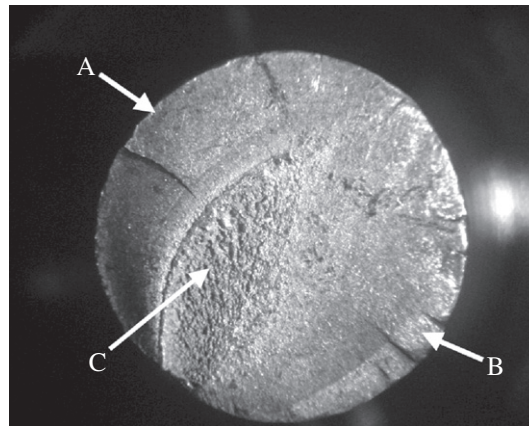
Fig. 2 shows a macroscopic image of the fractured surface of the ball joint obtained by optical microscopy. Three different characteristic zones of the fracture are identified in the figure as zones A–C. Zones A and B indicate opposed zones where the

Fig. 2. Fracture surface of the failed ball joint.

crack growth started. These zones showed a smooth and curved appearance or beach marks. These zones are a clear indication of fatigue failure of the material. Furthermore, in zones A and B can be appreciated fracture features pointing towards the center of the fracture. These ratchet marks are typical of fracture on elements subjected to high stress concentrations. Zone C on the other hand shows a rough surface, indicating the final fracture zone of the element. This zone occupying

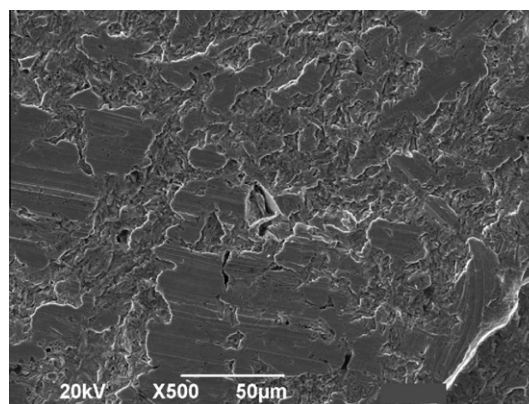
Fig. 3. SEM micrograph of fracture surface zone A.

approximately one quarter of the cross section of the element. Fig. 3 shows a SEM micrograph of fracture zone A (see Fig. 2). There can be appreciated the smooth surface and the beach marks characteristics of fatigue crack propagation. Fig. 4 shows a SEM micrograph of zone C (see Fig. 2), where the micro-voids characteristic of final ductile fracture of the element can be appreciated.

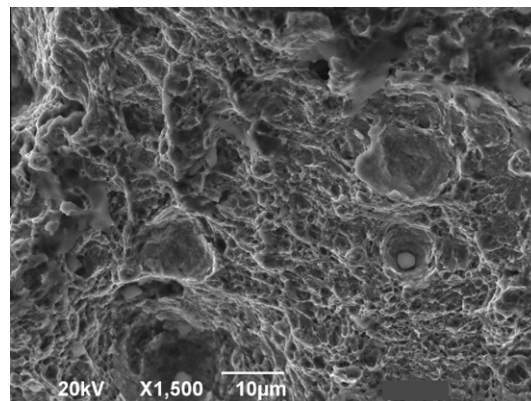
Fig. 4. SEM micrograph of fracture surface zone C.

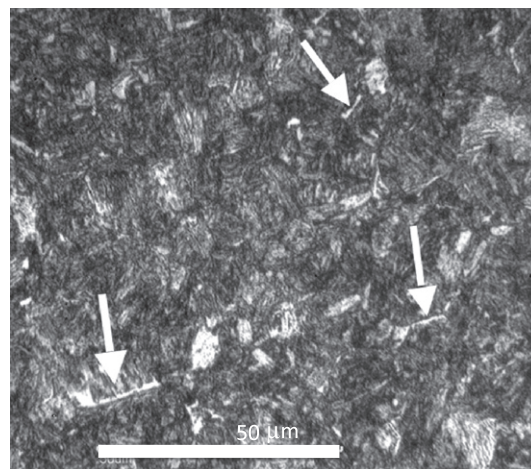
Fig. 5. Microstructure of the material. Etched with Nital 2%.

According to chemical composition analysis by OES, the ball joint was manufactured using an AISI-SAE 5140 steel. Fig. 5 shows the metallographic microstructure of the ball joint element. This micrograph shows a microstructure formed mainly by tempered martensite with acicular grains of ferrite on the grain boundaries (white grains indicated by arrows in Fig. 5). The presence of tempered martensite indicates that the material suffered a heat treatment of quenching and tempering. Despite the beneficial effect of increasing material toughness of acicular ferrite in low carbon steels [1–3], it has been found that acicular ferrite can decrease the fracture toughness and mechanical strength of heat treated steels when it appears on tempered martensite grain boundaries [4,5], as in the present case. The presence of acicular ferrite on grain boundaries can also induce a localized reduction on the hardness of the material, reducing the fatigue endurance limit, which along with the reduction on toughness can drastically reduce the life of the component. According to Murakami [6], the uniaxial fatigue strength σ_f can be related with the Vickers hardness H_v as:

326 MPa \pm 20.4 MPa. Despite the differences found on the endurance limit of the material by using Murakami's or Alsaran's approaches, it is evident that acicular ferrite reduces the endurance limit of the material in approximately 40%. This reduction on endurance limit is considered to be the cause of the fatigue crack initiation on the element, which was further enhanced by the contact stresses highlighted by the ratchet marks present on the fracture surface.

It is then suggested to modify the geometry of the ball joint to increase the loading section and reduce the contact stresses with the cage. It is also suggested to evaluate the heat treating processing conditions followed on the manufacture of the element to avoid the formation of acicular ferrite which further reduces the fatigue endurance limit of the element.

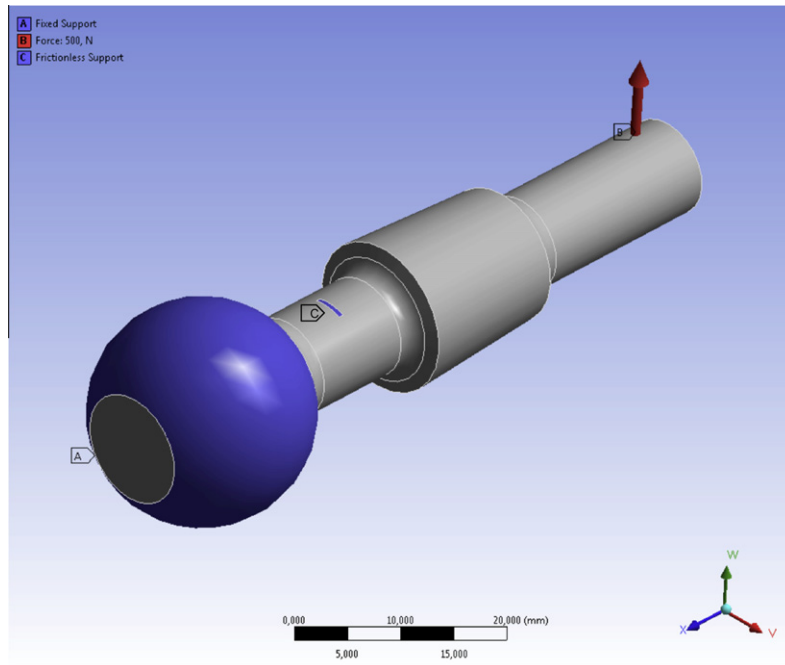
Fig. 6. Ball joint boundary and loading conditions used in the numerical analysis. A: Fixed support; B: Load 500 N; C: Fixed support.

1. A fixed contact in zone A (ball), shown in blue³ color in Fig. 6.
2. A lateral load B, assumed constant in this analysis to simplify the modeling, with a value of 500N and applied at the end of the element. This load value was used according to the experimental study of Ryu et al. [9], who found a value of lateral load of approximately 500N for a suspension system similar to the one studied here, so it is considered that this value of load represents a realistic estimate of the load applied to the element.

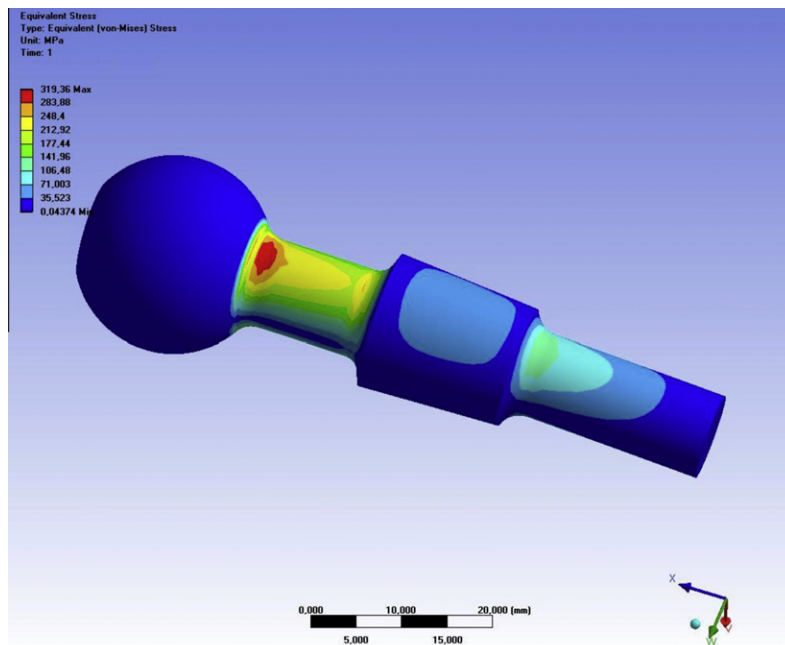
Fig. 7. Equivalent Von Mises stress distribution of the ball joint without contact support in C.

Fig. 7 shows the stress distribution on the ball joint element without the contact support patch C in place. In this case the maximum stress was found on the section change between the ball and the axis. This stress reached a maximum value of 319 MPa approximately. On the other hand, Fig. 8 shows the stress distribution on the element including the contact support

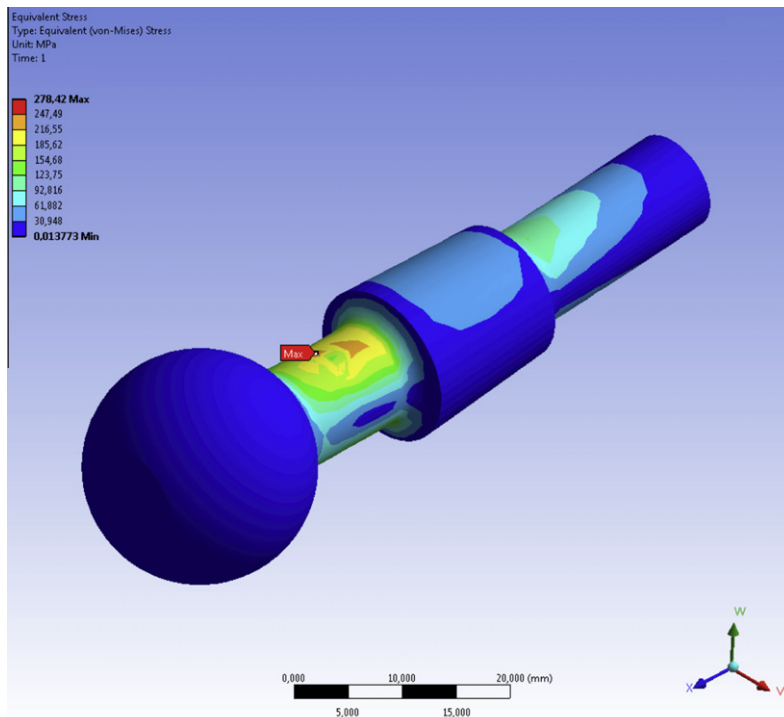
Fig. 8. Equivalent Von Mises stress distribution of the ball joint with contact support in C.

patch C in the calculations. In this case the maximum stress was found on the contact region between the axis of the element and its cage. This stress reached a maximum value of 278 MPa approximately, which is lower than the bulk fatigue endurance limit of this steel under normalized conditions, which reaches a value of 416 MPa [7]. However, this stress is close to the endurance limit found using Murakami's Eq. (1) for the acicular ferrite present in the grain boundaries of the material. Also note that the place where this stress is reached corresponds with the place where the fracture occurred in the ball joint element (see Fig. 1). The smooth beach marks accompanied by ratchet marks and a small final fracture zone (one quarter of the cross section of the element) confirm that the element suffered high stress low cycles fatigue conditions initiated at the acicular ferrite on the grain boundaries, followed by fatigue crack growth.

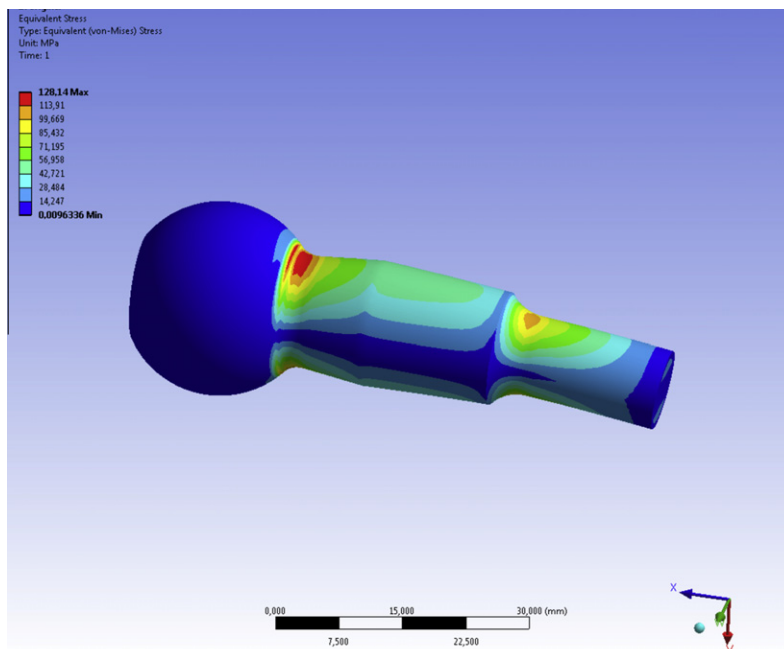
Fig. 9. Equivalent Von Mises stress distribution of the modified ball joint without contact support in C.

In order to reduce the contact stresses on the ball joint element, a change on the geometric design of the element was proposed. In the proposed design, the cross section of the element was increased as shown in Fig. 9. This element was modeled using the same loading and boundary conditions employed for the failed element, as shown in Fig. 6. Fig. 9 shows the stress distribution on the proposed ball joint, being modeled without the cage support. In this case the maximum stresses were found on the section change between the ball and the axis of the element, with a maximum value of 128 MPa approximately. On the other hand, Fig. 10 shows the stress distribution of the proposed design considering the cage contact patch C. In this case the maximum stress was found on the cage contact, as expected, with a maximum stress value of 151 MPa, which is almost half the value reached in the same zone by the failed ball joint and well beyond the fatigue endurance limit of the material.

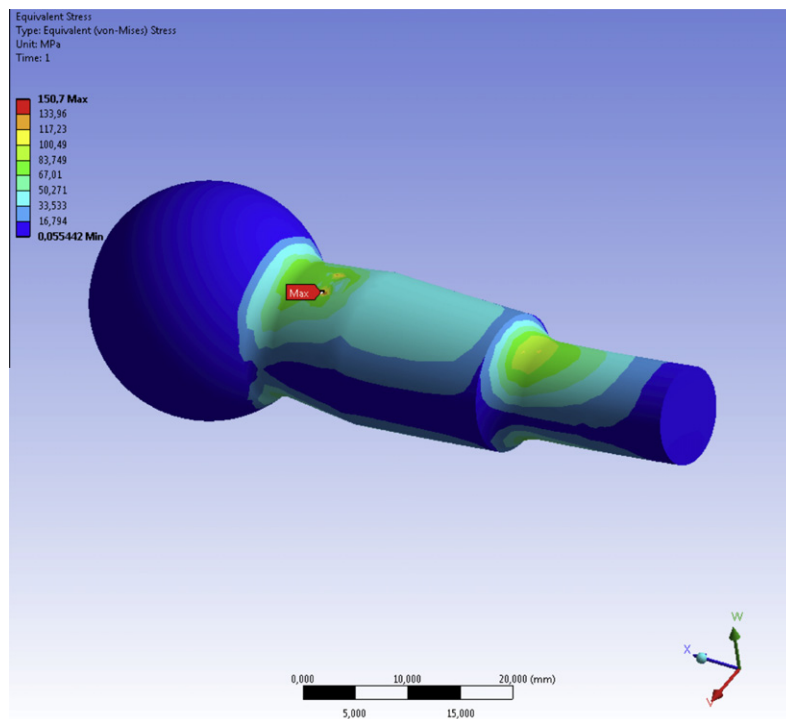
Fig. 10. Equivalent Von Mises stress distribution of the modified ball joint with contact support in C.
