Failure analysis of a civil aircraft landing gear

This paper describes the analysis and investigation of the causes of the failure of the main landing gear of a Cessna 402B civil aircraft. Optical analysis of the failed elements indicated possible fatigue crack failure initiation. However, further scanning electron microscopy examination ruled out this failure mechanism showing shear failure mode as the cause of fracture.

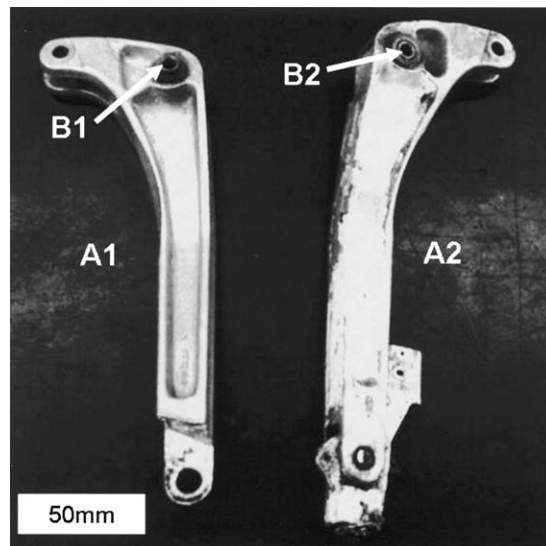
Fig. 2. Landing gear left and right locking linkages A1 and A2, respectively. Also shown is the location of the respective failed bolts B1 and B2.

Fig. 2 shows the two linkages as received for analysis after the accident. Linkage A1 shows fracture of the bottom clevis, with bolt B1 fractured at one end (see Figs. 3 and 4). Linkage A2 on the other hand, was received with clevis bolt B2 fractured at both ends (see Figs. 7 and 8).

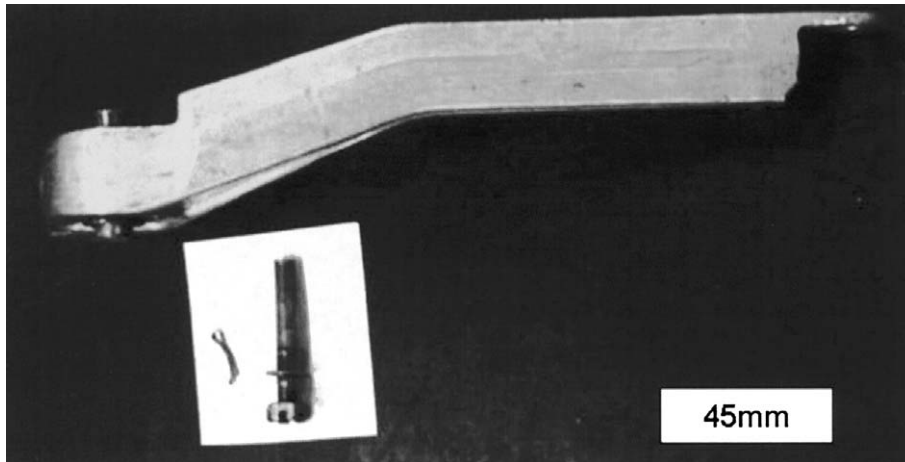
Fig. 3. Linkage A1 and bolt B1. Note the fracture of linkage A1 at the top right corner of the figure.

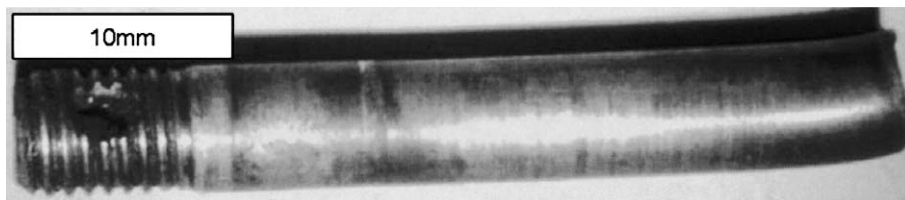
Fig. 4. Bolt B1.

The mounting direction of clevis bolt B1 on linkage A1 is shown in Fig. 3. This bolt failed at the right-hand side (Fig. 4). Stereographic examination of the fractured surface reveals a typical mode II or shear loading fracture with the arrow indicating the zone where the fracture began (Fig. 5). Also note the slightly bent tip of the bolt (right-hand side of Fig. 4) which is a feature usually found on shear induced failures.

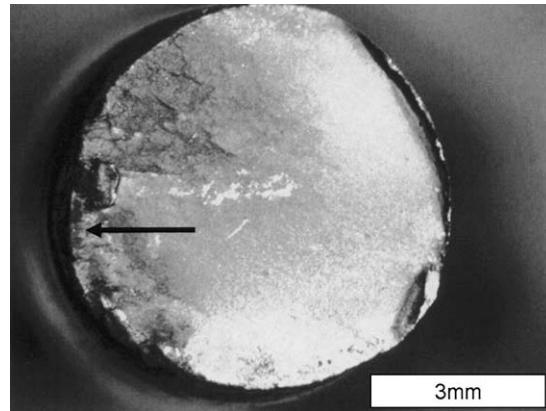
Fig. 5. Stereoscopic micrograph of the fractured surface of bolt B1. The arrow points toward the fracture initiation.

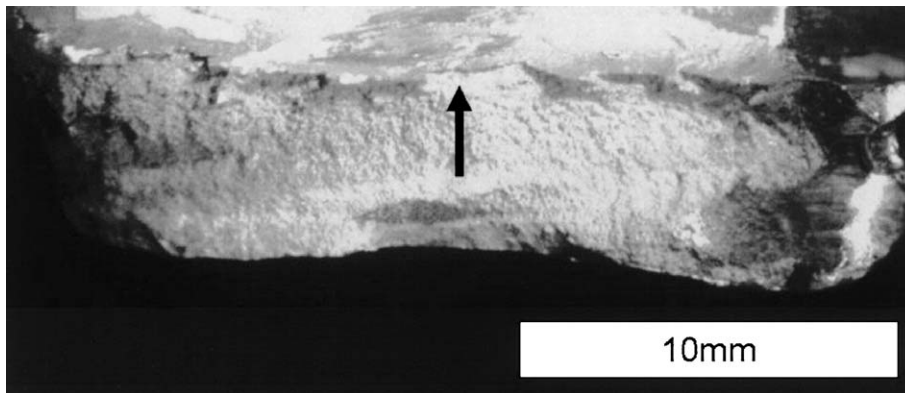
Fig. 6 shows the fracture surface of the failed clevis of linkage A1 (see also Fig. 3). The fracture surface indicates crack opening mode I loading failure, initiating the crack at the internal surface of the element as indicated by the arrow.

Fig. 6. Stereoscopic micrograph of the fractured surface of the clevis of linkage A1. The arrow points toward the fracture initiation.

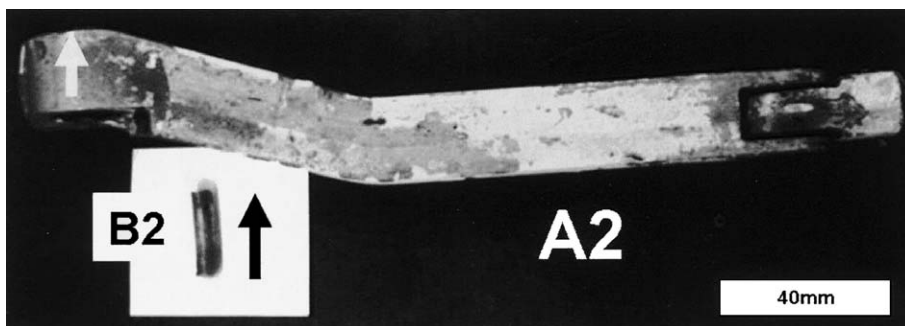
Fig. 7 shows linkage A2 and its corresponding clevis bolt B2. The arrows indicating the mounting direction of bolt B2. Fig. 8 is a macroscopic image of bolt B2 with the arrow also indicating the mounting direc-

Fig. 7. Locking linkage A2 and bolt B2. Arrows indicate the mounting direction of the bolt.

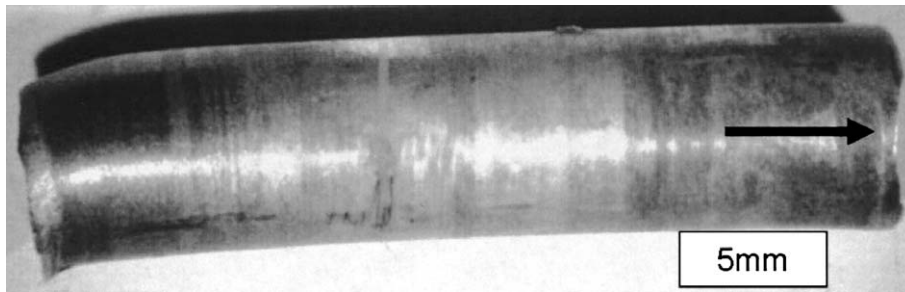
Fig. 8. Bolt B2.

tion. It is worth noting here the bent left-hand tip of bolt B2 in comparison with the straight right-hand tip in the same figure.

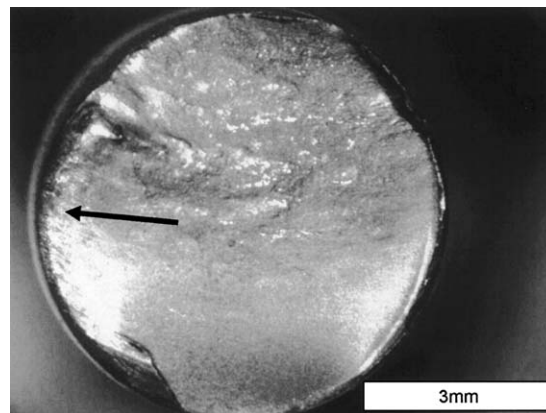
Fig. 9 shows the fractured surface of the left-hand side tip of bolt B2. This surface displays similar characteristics to the fracture surface shown in Fig. 5 for bolt B1, with shear fracture mode prevailing, also

Fig. 9. Stereoscopic micrograph of the fracture surface of the left-hand side of bolt 2 in Fig. 8. The arrow points toward the fracture initiation.

accompanied by bending of the left-hand side tip of the bolt. Fig. 10 on the other hand shows the fracture surface of the right-hand side of bolt B2. This surface exhibits different characteristics when compared with the respective fractured surfaces of the bolts analyzed previously, with a less rough appearance in zone A

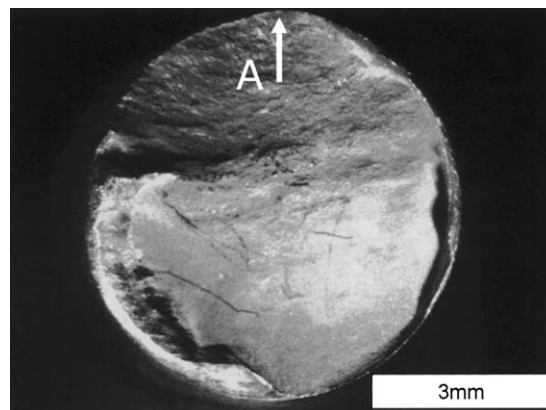
Fig. 10. Optical macrography of the fracture surface of the right-hand side of bolt 2 in Fig. 8.

(see Fig. 10). This zone also displays what appear to be fatigue beach marks, which along with the straight right-hand tip fracture could indicate a pre-existent crack in the bolt. However, higher magnification SEM analysis revealed that the failure was indeed caused by shear loading mode as for the other fractured bolt surfaces and no evidence of fatigue was found, as shown in Fig. 11. This apparent fatigue marks can be misleading and care must be taken in order to assess a realistic failure cause.

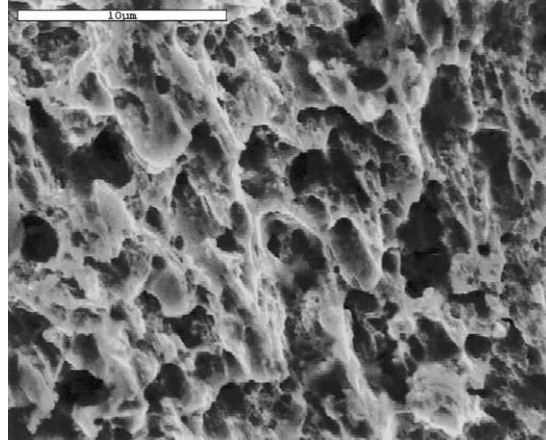
Fig. 11. SEM micrograph of zone A in Fig. 10 showing ductile shear fracture.
