Building monitoring during the partial implosion stage

J. Garcés¹, J.C. Botero¹, D. Murià-Vila²

(1) Universidad EAFIT - Colombia, (2) Instituto de Ingeniería- UNAM – México

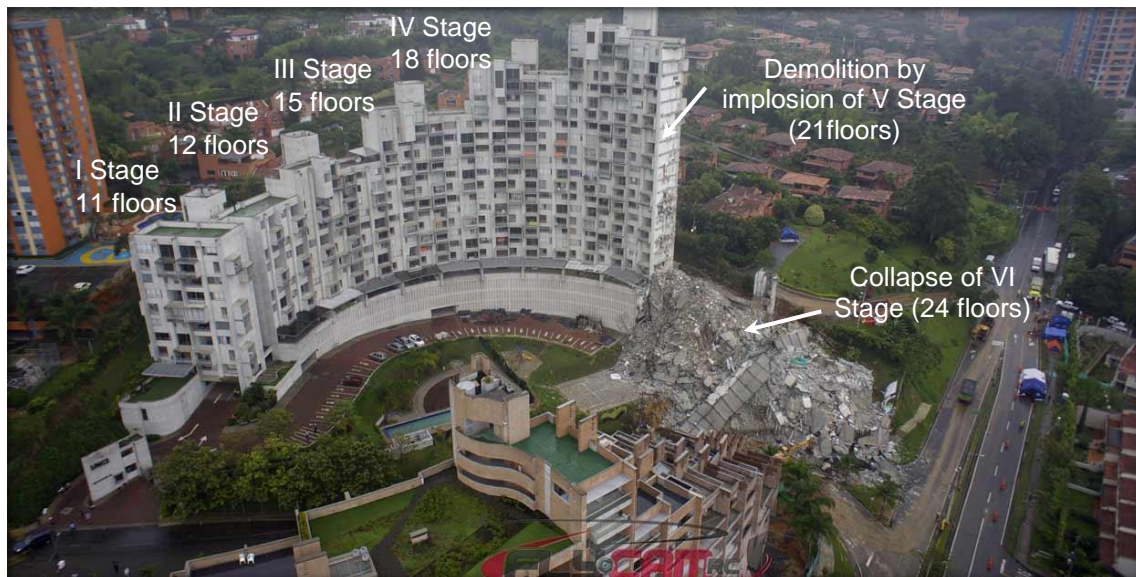
On October 12, 2013 the SPACE building located in Medellin city, Colombia, suffered a partial collapse of the VI stage that caused damages in the rest of the building (Figure 1). Those damages affected notably the stage V; therefore its demolition was necessary and was done on Thursday February 27 2014 at 13:52 UTC hours, through an implosion process. EAFIT University performed the monitoring survey of the remaining four (4) towers in order to register their behavior and to obtain the dynamic properties of the structure through a period of thirty (30) days after the implosion.

Figure 1. SPACE building after collapse of VI stage

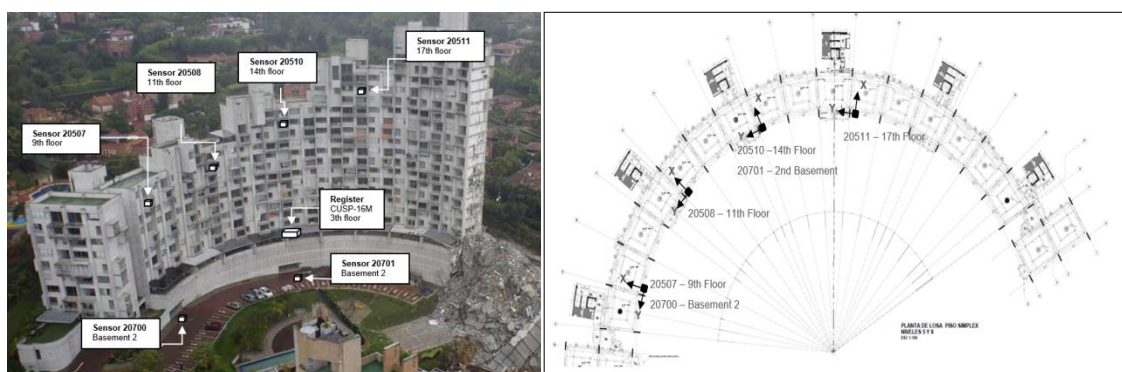
The building was instrumented in strategic locations of the structure in order to register the main movement amplitudes produced during the monitoring phase. Six New Zealand (CUSP) manufactured triaxial accelerometers were used located as shown in Figure 2. The accelerometers used were connected to a central recorder through conventional Ethernet cables.

Figure2. Location and orientation of the accelerometers in the SPACE building

The alignment of the sensors was referenced to three local coordinate axes, X, Y and Z as shown in Figure 2. The X-axis was aligned parallel to the direction of the biggest columns dimension (Transverse or radial direction). The Y-axis was oriented in the direction perpendicular to the X-axis (Longitudinal and tangential direction) and the Z-axis was in the vertical direction.

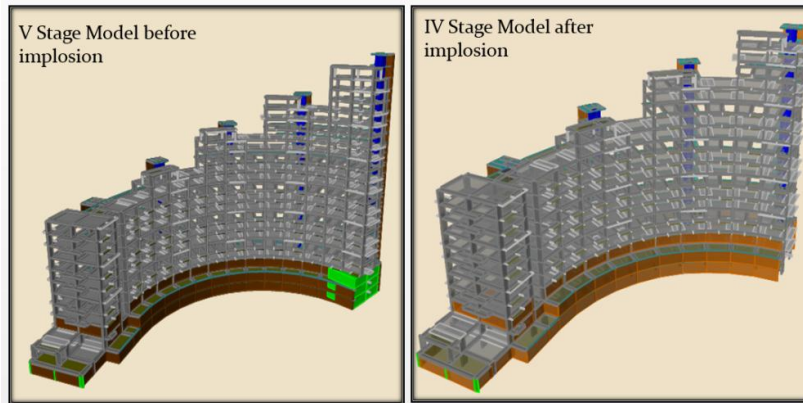
Figure3. Three-dimensional model before and after the implosion

The frequencies identified in the analytical model (Finite element software) before the implosion were 0.60, 0.73, 1.11, 1.63, 1.89 and 2.36 Hz. Frequencies corresponding to 1.11 and 2.36 Hz belong to the torsional/rotational mode.

After the implosion, the structure loses V stage and the model (Finite element software) reflects this fact. The frequencies identified in this case were 0.68, 0.81, 1.19, 1.89, 2.22 and 2.62 Hz. Frequencies corresponding to 1.19 and 2.62 Hz belong to the torsional/rotational mode.

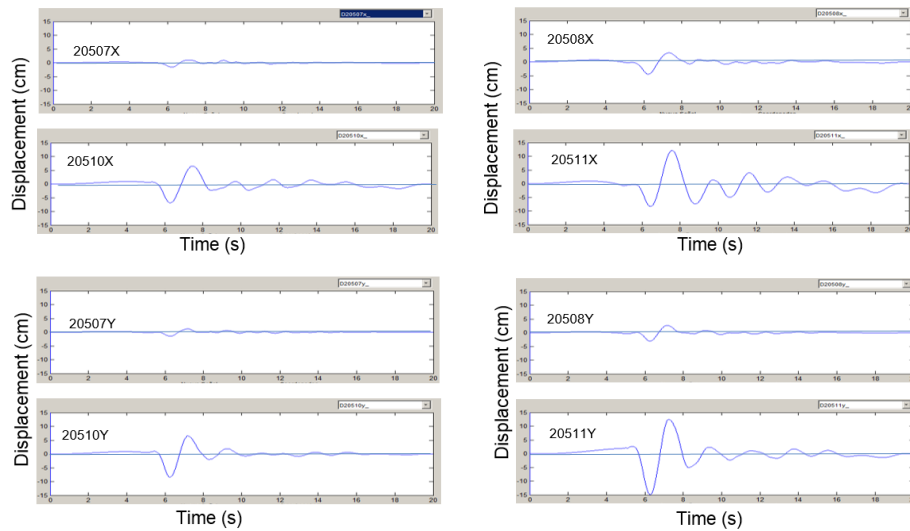
In Figure 4 the historical relative displacements to the structure base, produced by the implosion are shown. It is noteworthy that some initial displacements are seen before the implosion, which are the result of the signals numerical integration process and also suggests a possible rotation of the building at the base due to the implosion.

Figure4. Relative displacements registered obtained for the X and Y axes on the implosion event (VF01)

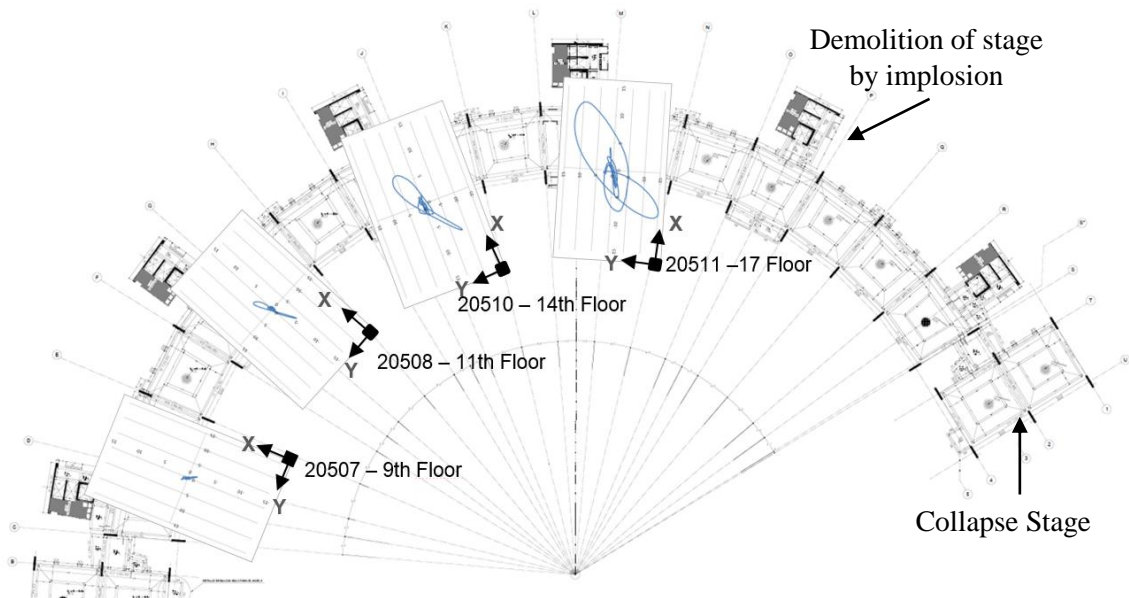
Figure 5 shows the trajectories of movement in the horizontal plane made by each point of the structure where the sensors are placed, making it possible to display the horizontal movements of the building after the implosion of stage V. It can be noted that the movement sensor 20511 located on the 17th floor and close to the implosion area, presents an elliptical motion which happens to be about 10 times higher than that recorded by the sensor 20507 in the 9th floor for both X and Y directions .

Figure 5. Horizontal path journeys made by the spots where sensors were placed

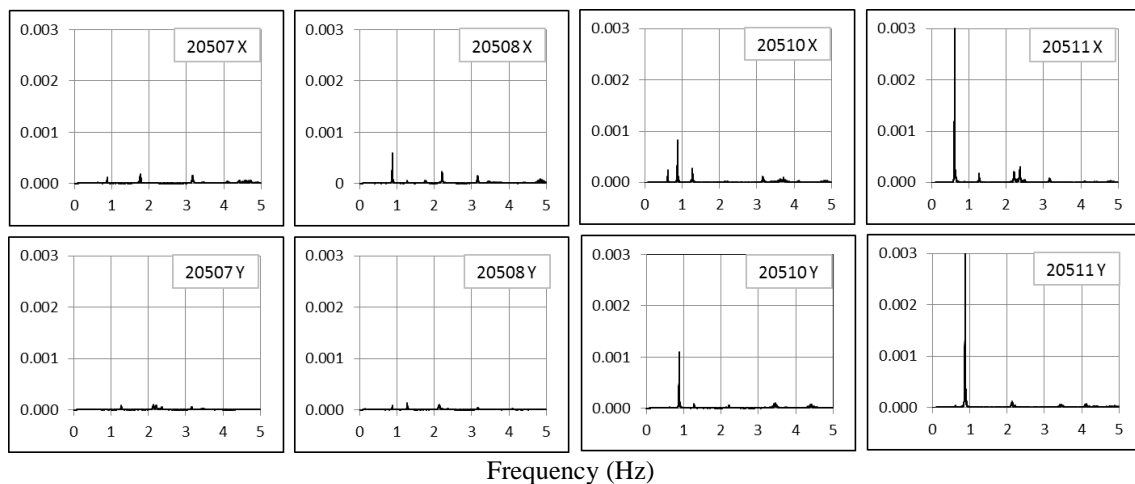
Figure 6. Average Fourier spectra from the ambient vibration test VA01

Figures 6 to 9 correspond to events prior to the implosion. It was determined that the frequencies associated with the first mode were close to 0.62 and 0.87 Hz, for the X and Y directions respectively. For the second mode values near 1.28 and 1.77 Hz for the X and Y directions respectively were obtained.

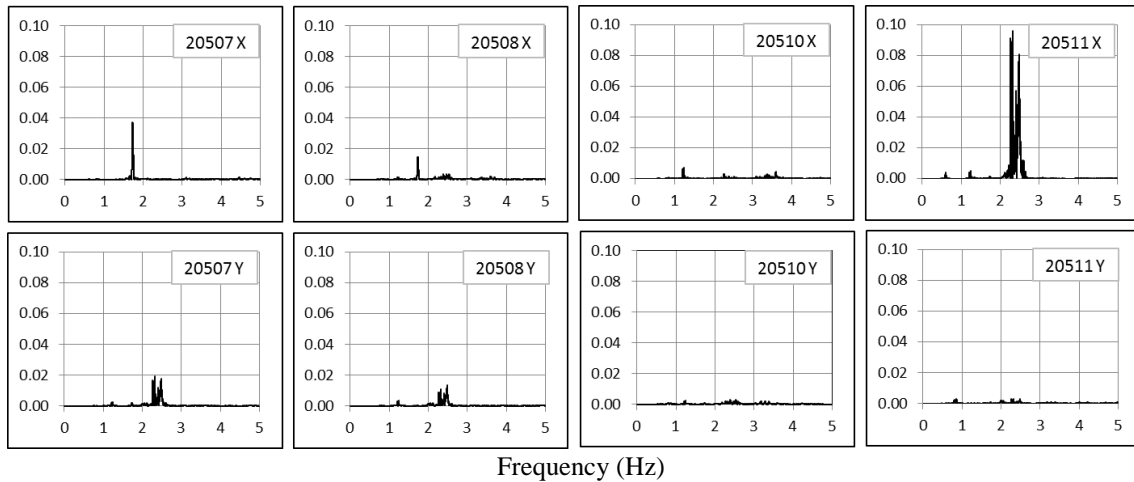
Figure 7. Average Fourier spectra obtained in the seismic event SI01

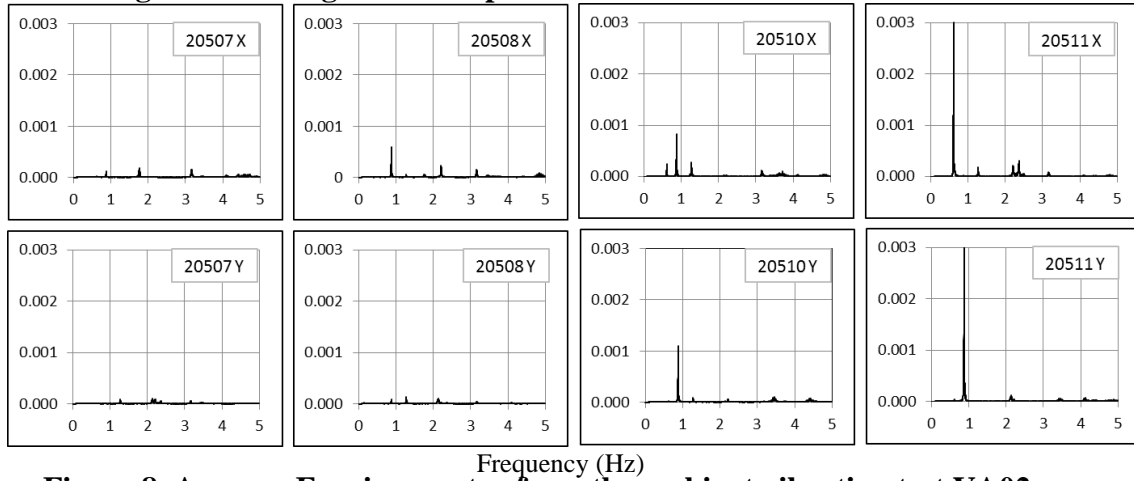
Figure 8. Average Fourier spectra from the ambient vibration test VA02

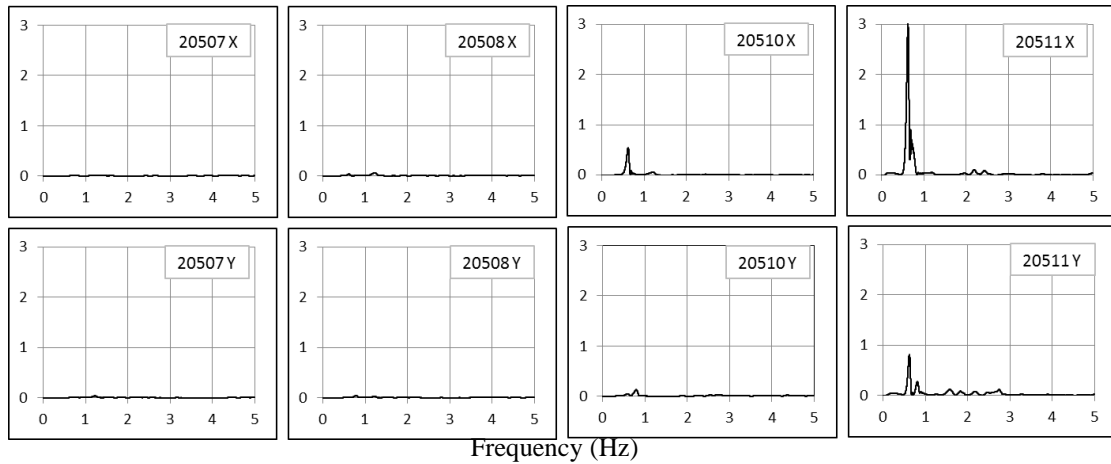
Forced vibration test associated to the controlled demolition of the slabs that were hanging after the implosion (VF02) shows variations in the frequency due to the explosive charges and to the collapse of stage V. For this case frequencies associated to the first mode were obtained equal to 0.63 and 0.82 Hz, for the X and Y directions respectively. For the second mode the obtained frequencies were close to 1.23 and 1.59 Hz, for X and Y directions respectively.

Figure 11. Average Fourier spectra calculated from the registers obtained during the demolition of the slabs attached in the IV Stage IV VF02

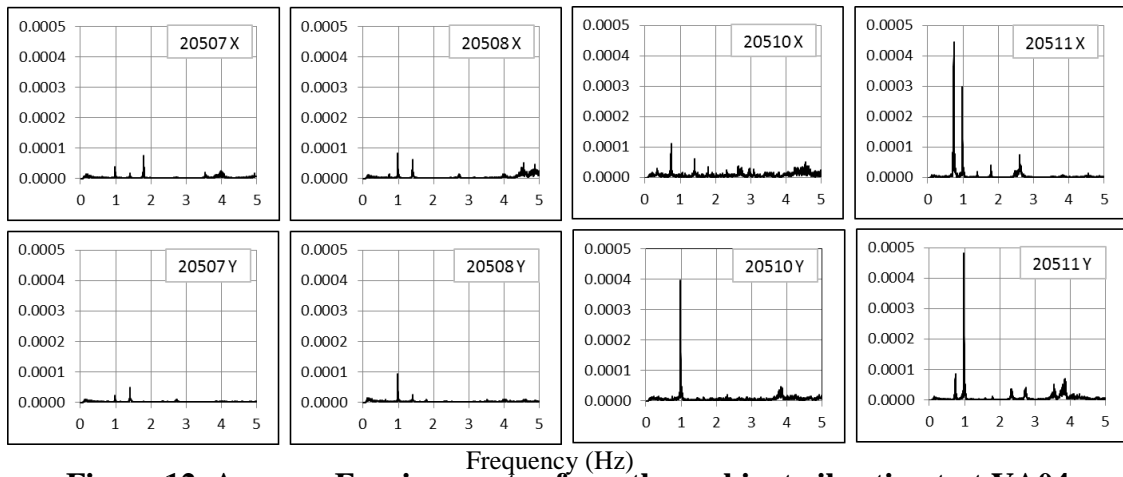
Figure 12. Average Fourier spectra from the ambient vibration test VA04

The final ambient vibration test (VA04) was performed after the controlled demolition and the same frequencies reported in the case VA03 were obtained.

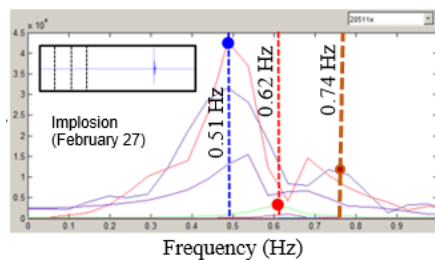
An important aspect that was observed during implosion corresponds to the variation of the fundamental frequency in the X direction. Before the implosion, the first mode frequency had a value of 0.62 Hz. During the implosion this value decreased to 0.51 Hz and after the implosion the frequency stepped to 0.74 Hz. This change is shown in Figure 13 where Fourier spectrums are illustrated in sections. A record of 30 minutes was taken and windows of 20 s, approximately were generated. This allowed seeing the frequency evolution during the implosion of stage V.

Figure 13. Average Fourier spectra by tranches during the process of implosion and demolition
