Failure analysis of a civil aircraft landing gear

This paper describes the analysis and investigation of the causes of the failure of the main landing gear of a Cessna 402B civil aircraft. Optical analysis of the failed elements indicated possible fatigue crack failure initiation. However, further scanning electron microscopy examination ruled out this failure mechanism showing shear failure mode as the cause of fracture.

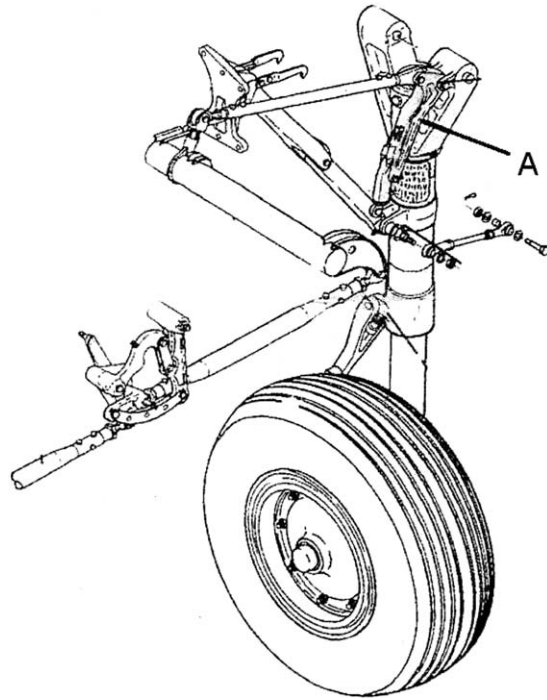
Fig. 1 shows the main landing gear of the Cessna 402B aircraft. Linkage A locks the landing gear at vertical landing position. This linkage is subject to high loads at landing and high shear stresses are applied

Fig. 1. Schematic showing the Cessna 402 civil aircraft landing gear. Locking linkage A is shown.
